# Technical Memorandum

## Fisheries and Aquatic Biota

**Blue Water Bridge Plaza Study  
St. Clair County, Michigan**

MDOT Contract No. 2002-0512  
JN 57779

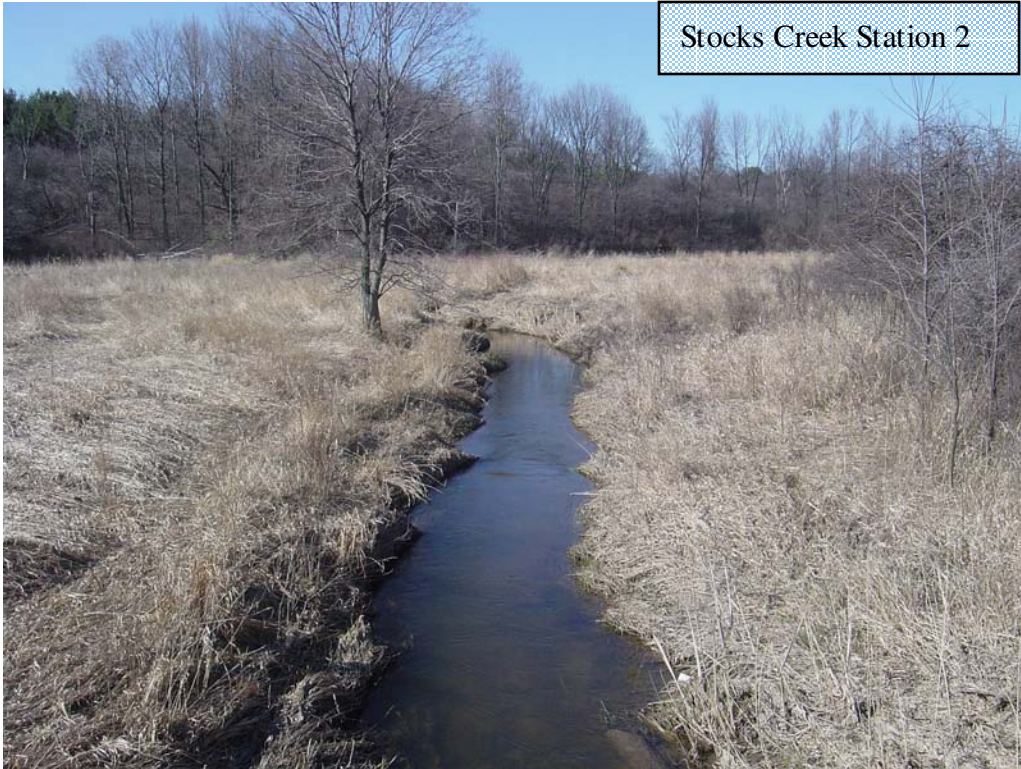
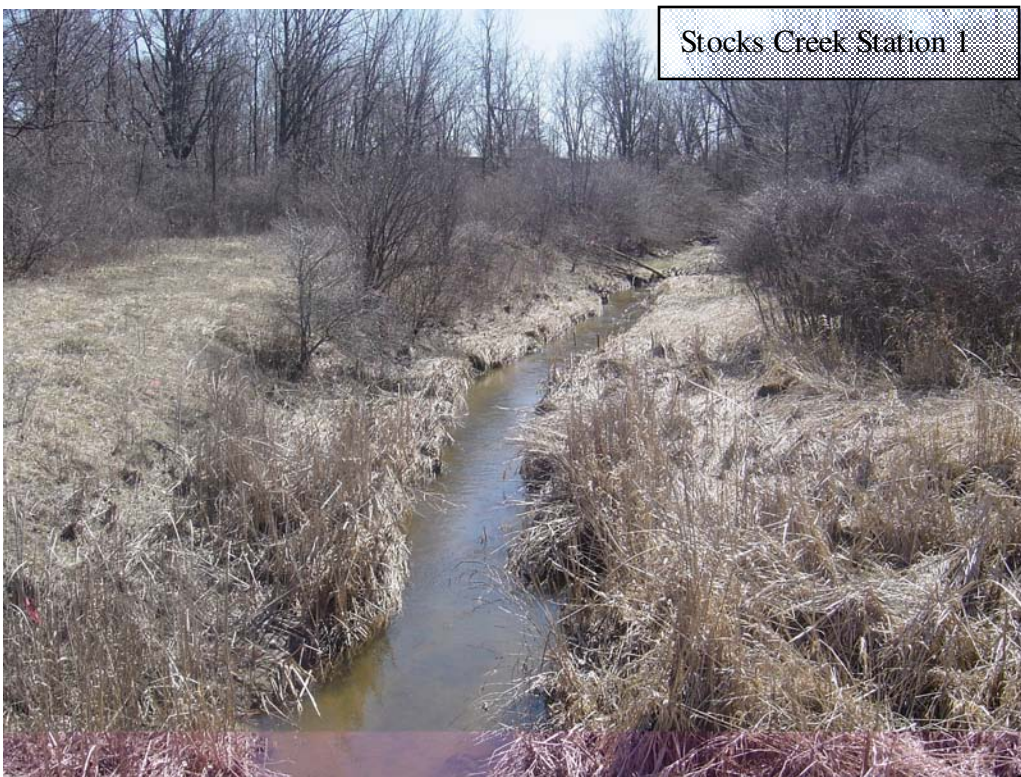
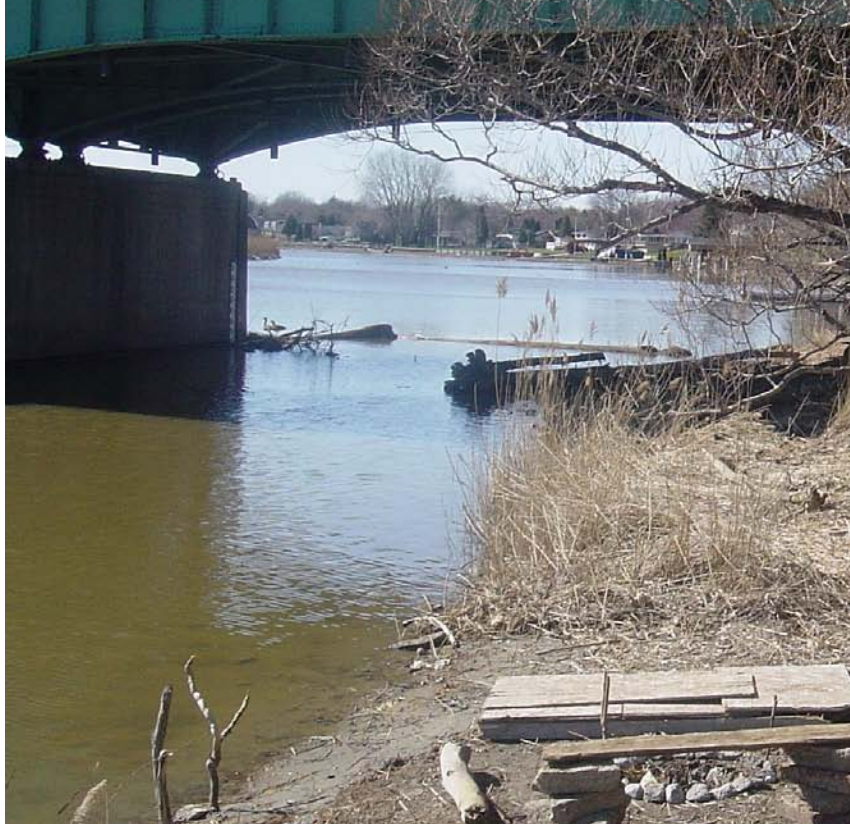
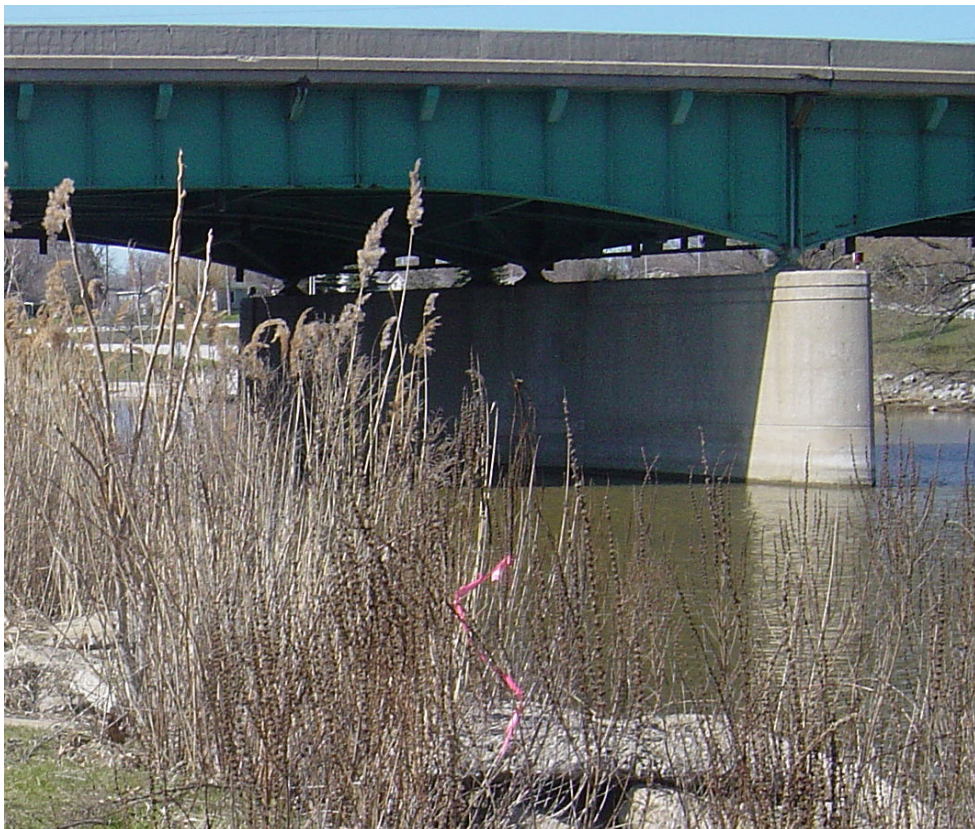
Photographs of Sample Stations for Stocks Creek  
and  
Photographs of Sample Stations for the Black River
